## **Historic Context and Management Plan for the Quarry Pond Archeological Complex on Fort Drum**

Susan I. Enscoe and Carey L. Baxter

April 2012

Final report

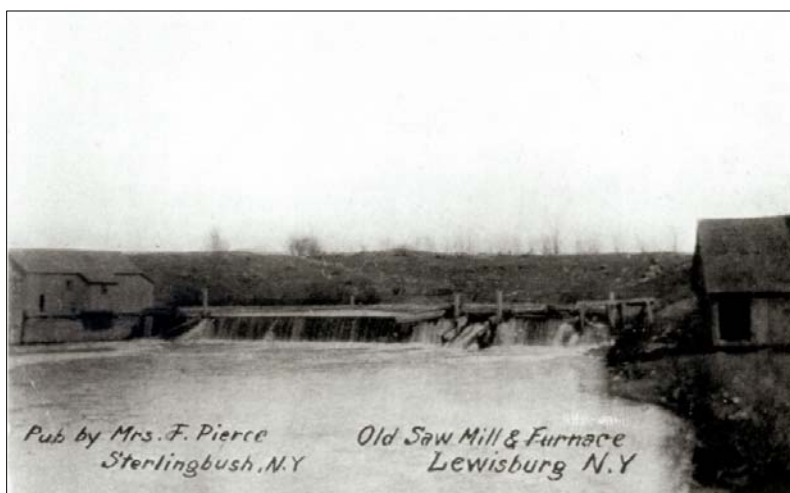
Figure 3. Lewisburg river industries, photograph labeled 1907 (Diana Town Historian's Office).

that would become Lewisburg. A photograph probably taken in the early 1900s shows the dam and sawmill on the left side of the image (Figure 3). It is not known, however, if the structure in the image is the original or a newer version. The initial activity at the site that would become Lewisburg is prophetic because the village would become defined by industry. Timber was soon superseded by iron production, and the ebb and flow of the village mirrored the fortunes of the iron industry.

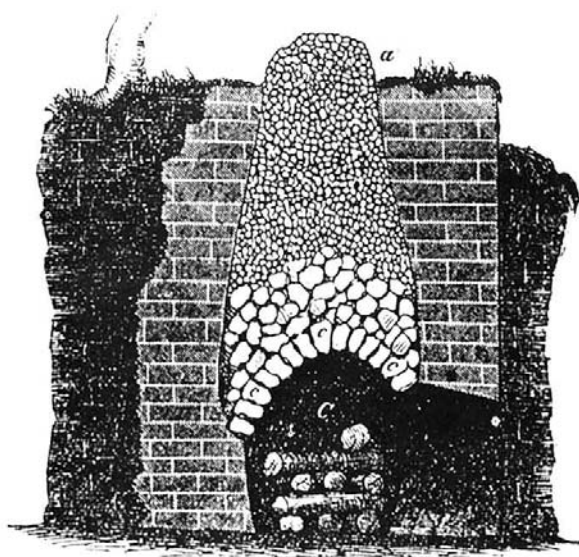
Figure 16. Cross-section of the base of an early wood-fired lime kiln (Gilmore 1874).

The process of burning created a chemical reaction, breaking the chemical bond between calcium oxide and carbon dioxide in the calcium carbonate limestone, and leaving the pure calcium oxide or “quicklime” behind. This process required prolonged burning, so kilns were designed for slow, continued burning. Stone kilns from the early nineteenth century, known as “intermittent” kilns, had square or circular fieldstone retaining walls. Inside the kiln, the limestone was placed over a stack of firewood and larger stones (Figure 16). A primary drawback of this type of kiln was the necessity to completely cool the kiln before the lime could be removed and the next cycle started.<sup>42</sup>

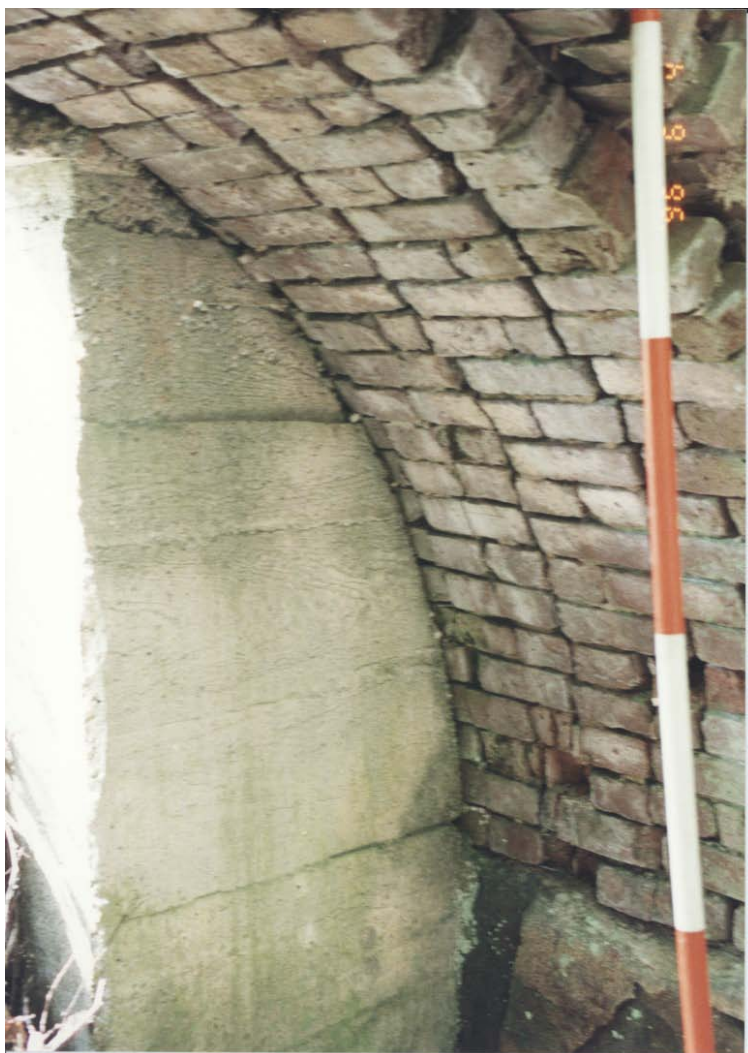
Figure 17. Hearth interior, lime kiln near Quarry Pond, 1996 (Fort Drum Cultural Resources Section).

It is highly likely that the Quarry Pond kilns were typical in their construction and operation as other perpetual kilns. Their location near an extraction site, against a hillside, and square exteriors with circular interior hearths—all would indicate design characteristics of the perpetual kiln. The use of cement in one the kilns for the exterior lintel and surrounding wall may have been original or may have been a later attempt to shore up the kiln (Figure 17). It is also possible that this kiln was constructed in the last half of the nineteenth century to expand production.

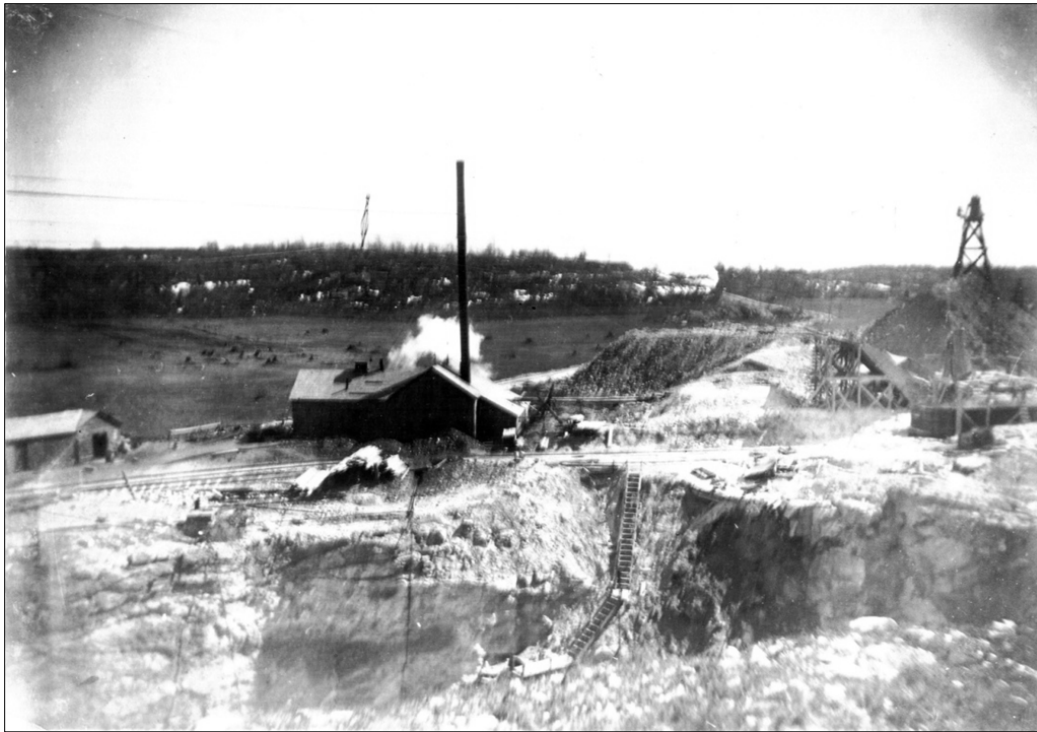
Figure 19. Lime quarry at Lewisburg, undated (Diana Town Historian's Office).

Another view of the quarry in operation (Figure 19) shows the buildings and activities alongside the quarry. In the center of the photograph is the boiler building, which produced steam to run the mining and crushing equipment. Large pipes can be seen exiting the building on the right and leading to the crushing or deposition facilities at the right side of the photograph. There also appears to be a smaller scale piping or hosing emanating from the quarry side of the building and proceeding down into the quarry itself. On the hill to the far right is the other derrick tower for lifting and transferring the stone. Spoil piles are visible in the central background, and the railroad spur is seen approaching the quarry from the right center background, heading toward the left center of the photograph. It is not possible to tell if the spur winds around to the quarry rim or if those tracks are separate.

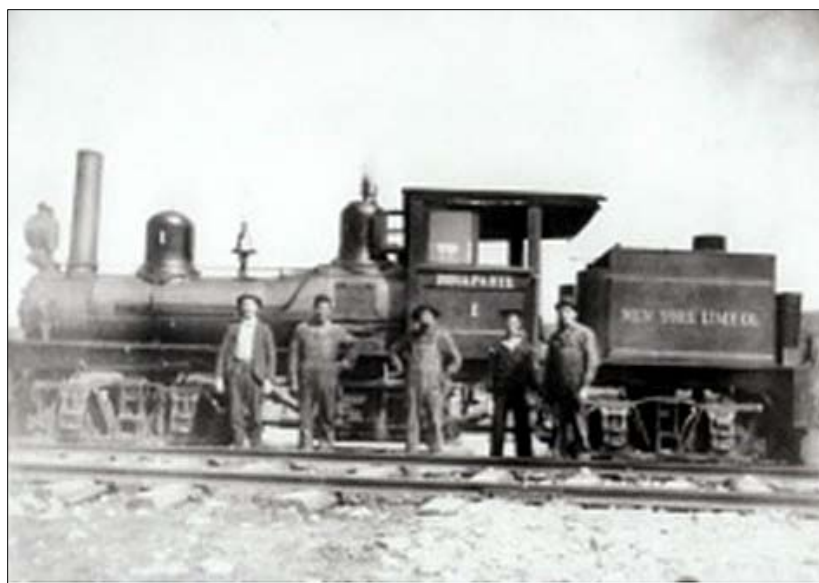
Figure 23. New York Lime Company engine, undated  
(from collection of the late Isabel Muir, Harrisville, NY, used by family permission).

It is not known exactly when the New York Lime Company installed this rail link, but the company owned locomotives by 1905. Engine 1501 (shown in Figure 23), was constructed for the New York Lime Company in 1905 by Shay Locomotives, under the company name of Lima Locomotive & Machine Company. The wood- and coal-fired engine continued to serve the New York Lime Company (and later the Basic Refractories Corporation) until 1922, when it was sold and the corporation purchased Shay Engine 2881. Basic Refractories also owned two other locomotives by Shay: Engine 553 (scrapped in 1917) and Engine 2755 (date unknown).<sup>51</sup>

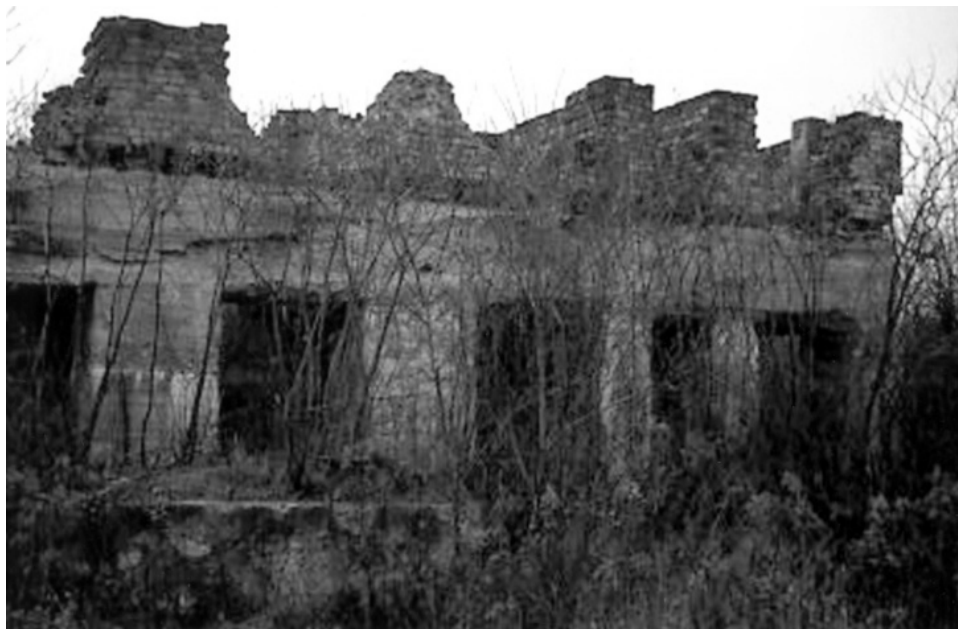
Figure 24. Ruins of structure at Quarry Pond, 1974 (courtesy of Jack Gormley, Carthage, NY).

There are no complete standing buildings, and the concrete foundations have been used for target practice, scattering pieces all over the site (Figure 38). A partial standing structure remains on the site (see Figure 24). This could possibly have been the support structure for a large kiln, or it could have been part of the stone crushing operation. The area around this partial standing structure is likely undisturbed.

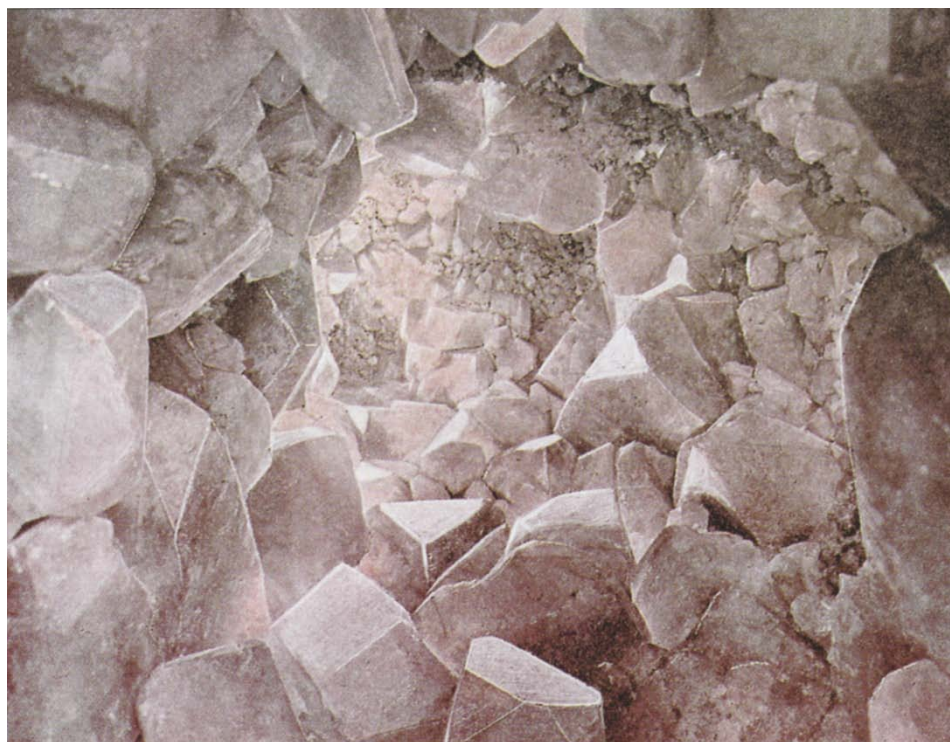
Figure 30. Artist's rendition of calcite cave reconstruction, 1918 (MATRIX Vol. 7, No. 3, 1999: 113).

The crystals were placed from back to front, attached to the framework, and then held in place with a combination of plaster and cheese cloth laid over a small-mesh wire screen. This arrangement served the dual purpose of hiding the framework and simulating a cave interior. The crystals were placed over the ceiling and all the way around to the front, oriented toward a two and one-half square foot window for viewing purposes. Finally, a raised false floor displayed the largest crystals in a simulation of where they had been found in the cave. Each crystal in the entire arrangement was placed with an eye toward fitting it exactly to the next one and making sure the best crystal faces were displayed both to the viewer directly and in the reflected view from the mirrors.<sup>74</sup> There were twenty-one dim electric lights hidden behind the crystals with the deepest colors, which provided backlighting to bring out the color and give the crystals a soft glow.<sup>75</sup> As described in the 1918 annual report for the museum, “the clever disposition of the electric lighting brings out the deep rose shades shown by transmitted light and the amethyst color seen under reflected rays” (Figure 30).<sup>76</sup>

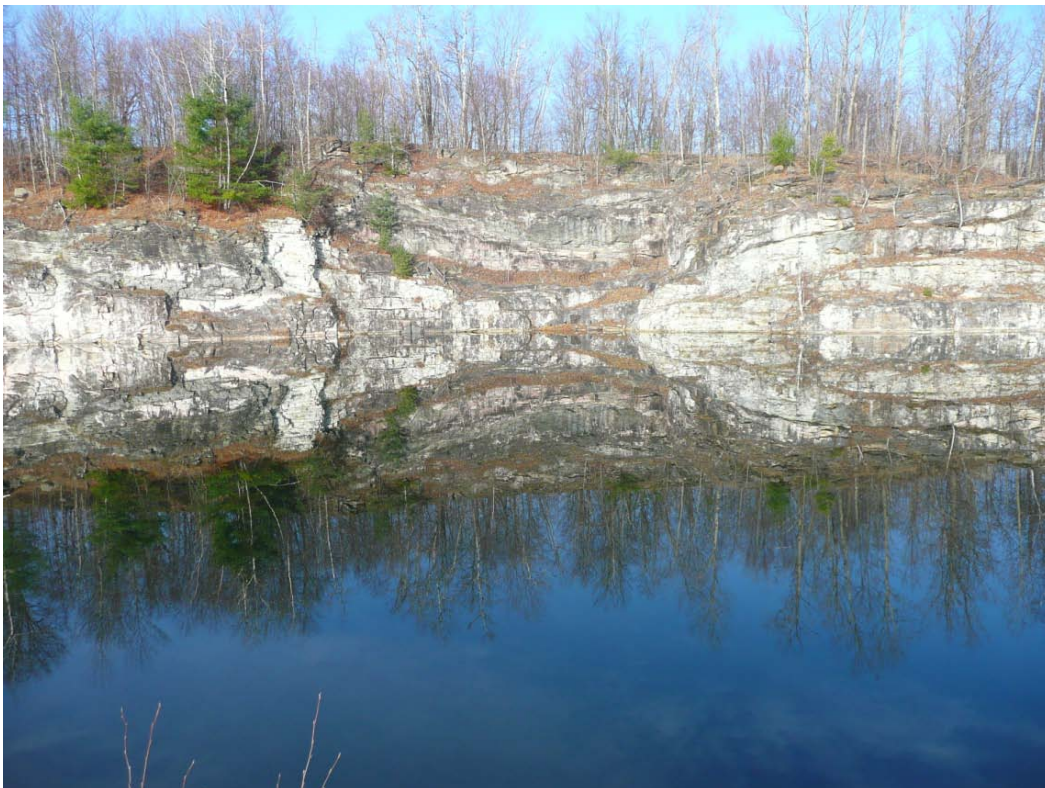
Figure 34. Quarry Pond on Fort Drum, 2010 (ERDC-CERL).

The Quarry Pond remains, with its sheer walls partially hidden by water (Figure 34). Except for a few relics removed in 1978, quarry artifacts lie on the bottom of the pond, untouched for eighty years. The ruins of three earlier lime kilns remain on the site, to the southwest of the lake (Figure 35 and Figure 36). The small lime kilns have collapsed over time, but the sites are undisturbed. The railroad spur is long gone, but the embankment serves as an access road to the area, continuing along FUSA Boulevard to the installation boundary and beyond, with remnants of a bridge across the Indian River still in place (Figure 37).<sup>119</sup>

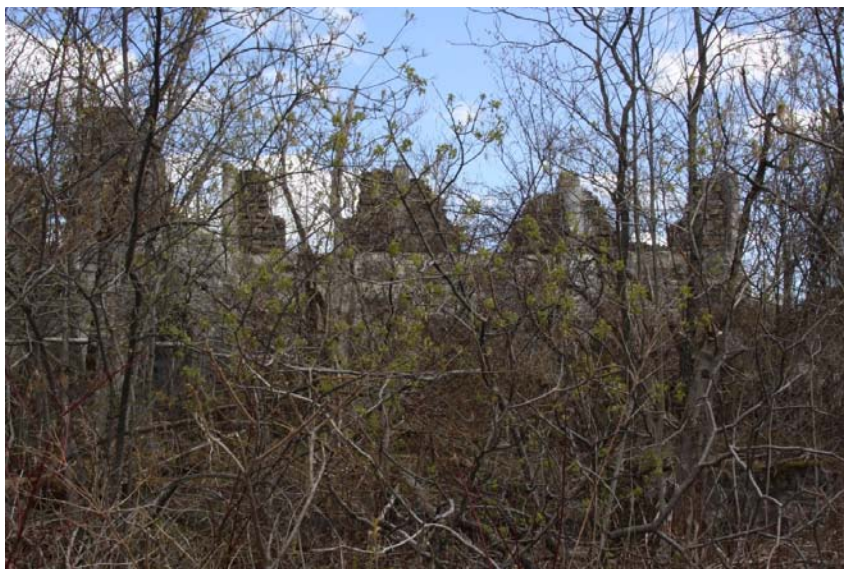
Figure 48. Quarry Pond Complex, Earth Day 2010 (Fort Drum Cultural Resources Section).

Photographs of the Quarry Pond Complex demonstrate that the area is heavily wooded and that trees are actively growing within architectural feature/remains (Figure 47, Figure 48, Figure 49, Figure 50). Additionally, the site revisit report from 2001 described portions of the site as being impassable by foot due to vegetation, and that some features within the site are obscured by vegetation.<sup>127</sup>

It is recommended that trees, dense brush undergrowth and any climbing or clinging vines and ivy be removed from the immediate proximity of the aboveground features to slow natural deterioration of the features. National Park Service's Guidelines recommend that coniferous trees which will not resprout should be cut down at ground level.<sup>128</sup> Deciduous trees should be felled, leaving twelve to eighteen inches of stump aboveground. Tree stumps and root systems should not be removed from the ground but should be allowed to decompose naturally in the soil. The tree cuts should be angled to facilitate water runoff from the top of the stump and slow the stump/root decomposition. Areas to be cleared of trees should include everything within and from two to three meters surrounding aboveground features, including the railroad berms. A swath of undergrowth and trees should be left between aboveground features and publicly accessible portions of the complex to discourage persons from exploring the features. All felled trees (including natural tree falls) should be removed from the site. Climbing or clinging plants should be removed from aboveground features with hand clippers. Holdfasts and roots attached to the features should not be pulled from the surface face but should be left to decompose in situ. Periodic revisits of the site should include efforts to remove saplings and shrubs from the cleared areas associated with features.
